Manhole Inspection Summary

Manhole # S11A1_006MH

Record Plat: **11A1** Node: **006** Status: **Other (Specify in comment)** Insp Date: **12/16/08 11:28 AM**

Location Address: **I 695w (exit 48b)** Cross Street: **S Caton Ave**

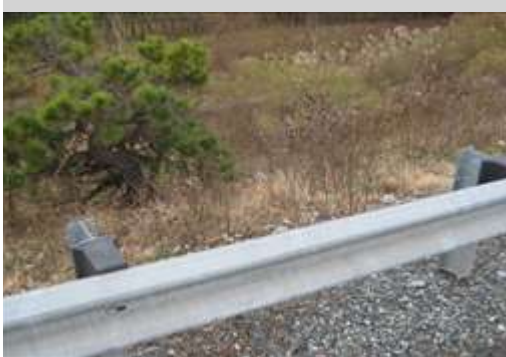
Location View

approximately 80ft from onramp

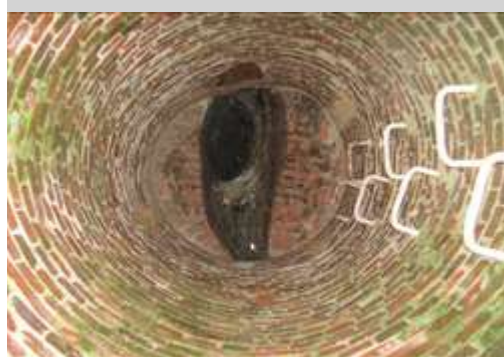
Top View

mhc over in channel

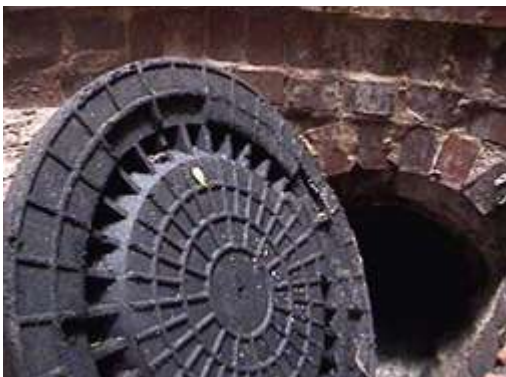
Misc

Comments **Mh has no frame...cover has fallen in manhole...unable to obtain measurements for I5 due to overhang.....see pics**

mh cover in fallen into channel

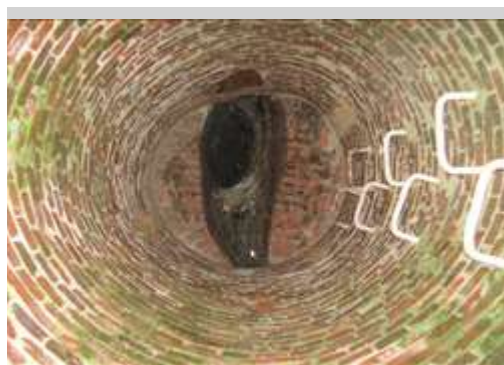
Defect 2

Steps Count: **9** Missing: **0** ☒ Corroded

steps corroded

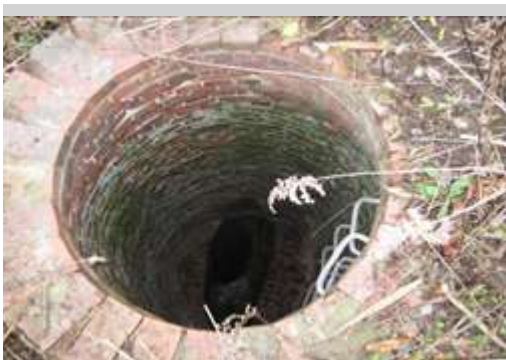
Defect 3

Corbel Material: **Brick** ☐ Parged Type:
Condition: ☒ Sound ☐ Cracked ☐ Root Intrusion ☐ Loose Brick ☐ Deteriorated
Infiltration: ☐ None ☐ Joint ☐ Cracks ☐ Mortar ☐ Roots ☒ Wall

corbel infiltration at wall, no frame or cover

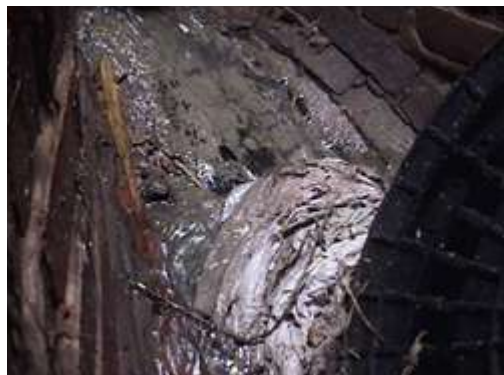
Defect 1

Channel Material: **Brick** ☐ Parged
Channel Exposure: **Fully Open** Junc Dist: **0** nearest .5 ft. Azimuth: **0**
Condition: ☐ Sound ☐ Cracked ☐ Root Intrusion ☐ Deteriorated ☐ Leaks ☒ Debris

channel debris

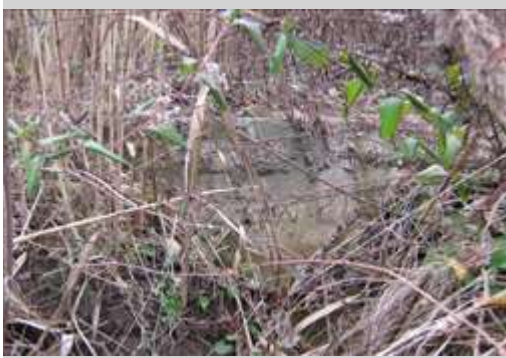
Defect 4

16" above grade

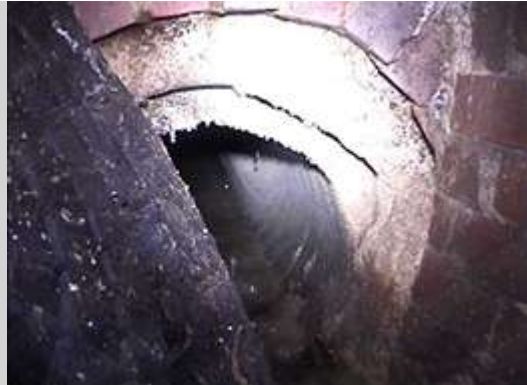
12 O'Clock Outflow

Pipe Height: **15.6** (in.) Rod and Bar (Angled)
Pipe Material: **Clay** ☐ Pipe Lined
Invert Depth: **14.69** (ft.) Flow Characteristics: **Fast**
Deposits: ☒ None ☐ Mud ☐ Sludge ☐ Debris ☐ Grease
Silt Depth: **0** (in.) Deposits Extent:
Infiltration: **None** Pipe Seal Cond: **Sound**

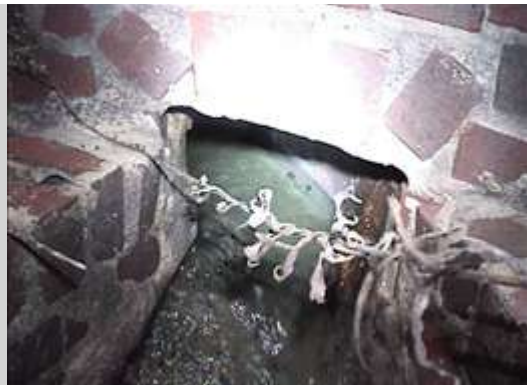
5 O'Clock Inflow

overhang above channel
